960-90 Series Information

[Volvo Maintenance FAQ for 7xx/9xx/90 Cars](#)

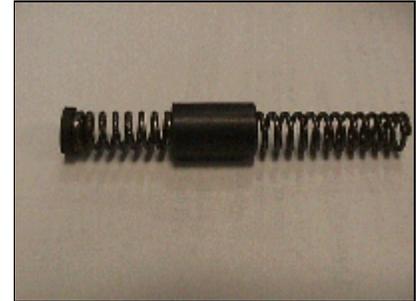
960 Oil Pressure Problems: Failing Oil Relief Piston.

[Tip from JT] As you know I have had some problems with no oil psi after I got the 2.9l back together. I thought that the oil pick-up was plugged with sludge or something. I know I did not want to drop that oil pan so I figured that I had nothing to lose by trying to clean the sump. I put in 6 quarts of the gunk parts cleaner (comes in 3 qt cans) thru the dipstick hole and let it set for 2 days. When I drain it the oil sump was spic & span! I flushed it with oil, then tranny oil, and then with oil again. I then filled two caulking tubes with mobil-1 0w-30 oil and with a rubber stop (with a center hole) pressurized the oil system thru oil filter inlet. I put

the filter on, filled the sump with oil, and cranked the engine. No oil psi! I had to know what the heck was going on with this no oil psi. Still not wanting to drop the pan I went after the new oil pump. When I got the pump off it did not look right to me. What I thought should be the oil psi relief valve looked strange. Never seeing one of these before in the new Volvo engines I was not sure how it was suppose to work. What I found was a cylinder in a cylinder with a spring going thru it. I went to Volvo and ordered everything I could (except the pump) that was associated with the pump. It was clear when I got the new parts. The inside cylinder used to be a piston. The wire snapping chipped away at the piston top everytime it would hit the stop. Since the relief valve is made out of PLASTIC with the force of the spring behind the piston top, it was chipped away until the spring blew the top on the piston off! No oil psi. The new piston is made out of steel. So this will not happen again. This was a new oil pump that had this plastic piston in it. I am told that the 850's use the same pumps. My sisters 850's oil pump took the big vacation about 2 years ago and I wonder if this was the cause. The casting date stamp on the oil pump in the 960 with the plastic piston was 98. So formational purposes, the next time you do a timing belt, you may want to check to make sure you do not have a plastic piston relief valve

[From JT] The good news is that you do not have to take the oil pan off to check/replace the relief valve piston. I never took my pan off. I am really happy that I did not have to take that step. I do not know how many oil pumps came with plastic pistons or when there was a change to metal ones, but I say rather safe than sorry. If you are coming up on a timing belt change, pull the crank pulley and the crank timing belt gear. You will see four Torx head bolts that hold the oil pump in. Remove the bolts and the pump slides straight out. The piston was about \$12 and the oil pump kit was about \$23 (including front seal, oil pump seal, oil pump gasket). If you have a plastic piston in the relief valve you will have to separate the oil pump by removing the back gasket and removing 2 small hex head screws. Push the piston out and put the new one in. That's all. When you get ready to install the oil pump back into the engine you will need a special tool to get the front seal over the crankshaft. I used a thin walled piece of pipe but I think the book called for Volvo tool #5455. It makes the job real easy to get the oil pump back on.
