## Engine: FI and Ignition Computers

### [Volvo Maintenance FAQ for 7xx/9xx/90 Cars](#)

### ECU Fuel Pump Control Circuit Repair.

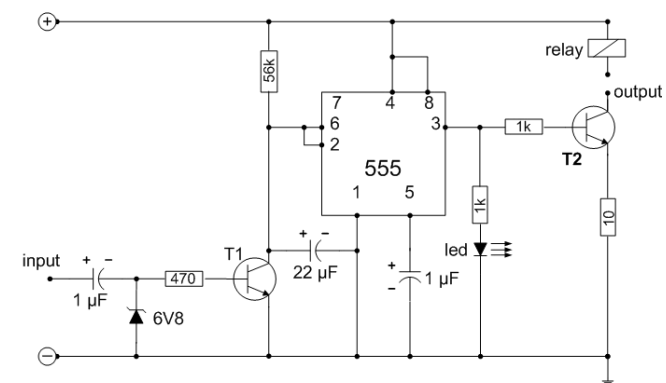
Missing pulse detector for fuel pump relay control

The 555 timer IC is operated as a slightly modified 'missing pulse' detector. Pulses from the EZK are used to hold the timing capacitor (22uF) in a discharged state. Should these pulses cease, the timing capacitor will charge through 390k and the timer output will change state, turning off the relay drive transistor BC140. The LED and 2k2 are a visual indication of the output state for testing purposes, and could be omitted. The 1uF capacitor ensures that the timer runs on power up, which gives the initial ignition on pump run. The transistor BC107 is really just a switch, and the zener 6v8 limits any spikes from the EZK.

T1: BC107, BC337 etc.	input: pin 1 of Jetronic 2.4
T2: BC140, 2N2219 etc.	output: collector of BC140 to pin 20 of Jetronic 2.4
zener diode: 6V8	power (+): pin 35 of Jetronic 2.4
relay: fuel pump relay	earth (-): pin 5 of Jetronic 2.4

It is possible to construct the circuit using stripboard about the size of a matchbox, which will fit inside the ECU, making a really neat repair. None of the components are particularly critical - most any transistors could be used, however the pump relay draws about 20mA. (This pump relay is actually part of a double relay - two relays in one case - often referred to as the 'LH Jetronic' relay). MOST IMPORTANT - Always disconnect the car battery before removing any ECU connectors. These ECU's are not well protected, and spikes will kill them.

I have been able to test the self-built replacement fuel-pump-relay control unit in my Volvo 940 from November 1990. My car has the OEM Bosch LH Jetronic 2.4 part no. 0 280 000 595. The loss of fuel pump relay control is a well known problem of the Jetronic 2.4 with part numbers 0 280 000 59x. This replacement control unit is the size of a match box and can easily be built inside the ECU housing. I found out that I had to change a few components in order for the unit to function properly: pump on after contact on - then fall off after one second - then on again when starting and motor running (= obtaining pulses from the ignition unit) - and fall off when engine stops running while contact on (for example after a car crash). It is basically according to what Michael Craig wrote above but with a few adjustments. The unit is basically a missing pulse detector. My Volvo is running OK now with the fix installed inside the original Jetronic.
